**SI 0078**  
For technical personnel only!  
1/2

# SERVICE INFORMATION

## VACUUM PUMP DAMAGE DUE TO INCORRECT ASSIGNMENT

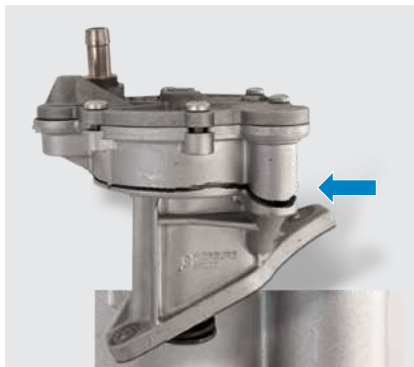
If an incorrect pump has been mounted, this will lead to breakage of the pump housing (see Fig. 1) during the initial engine start following installation, or even to breakage of the camshaft – and therefore to severe and expensive engine damage.

Fig. 1: Breakage in the pump housing

**In order to prevent damage, it is essential to check the chassis number, registration date and/or the part number of the old pump!**

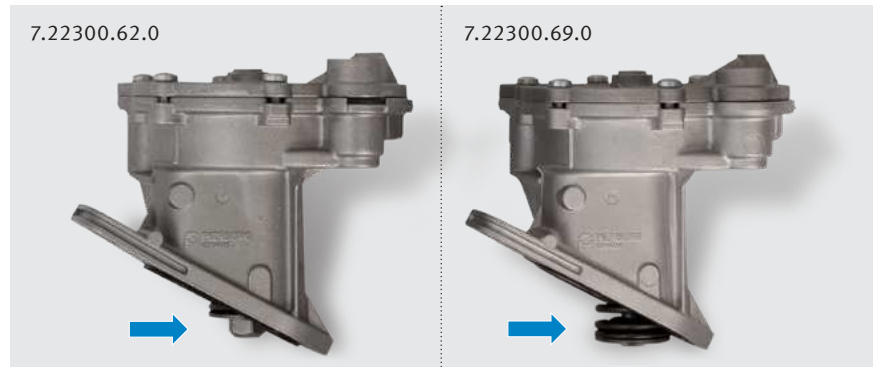
Fig. 2: Comparison of vacuum pumps

Vehicle: VW Transporter LT, T4 (platform, bus, truck, California), engine classification code: AAB		
Pierburg no.	7.22300.62.0	7.22300.69.0
Replacement for	7.22300.12.0	7.22300.19.0
Model year	up to 5/1994	from 5/1994
<b>Chassis number</b>	<b>up to 70-R-180 000</b>	<b>from 70-R-180 001</b>
VW part number	075 145 100; 075 145 101; 075 145 101 A	074 145 100 A
VW cylinder head no.	074 103 351 A	074 103 351 D
Motorservice cylinder head no.	50 003 101	50 003 113
Cylinder head cover surface	11 holes; Ø 5 mm	without holes
Pierburg tappet number	3.52124.06.0	3.52124.05.0
VW tappet number	075 145 307	074 145 307 B
Tappet length	71.0 mm	67.5 mm

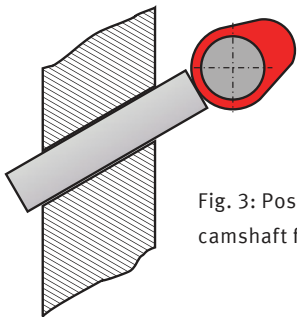
Fig. 3: Position of the camshaft for installation

In order to mount the pump with only a minimal amount of preload (max. 2 mm gap), the cam on the camshaft for driving the vacuum pump must be positioned on the opposite side of the connecting tappet (see Fig. 3) during mounting:

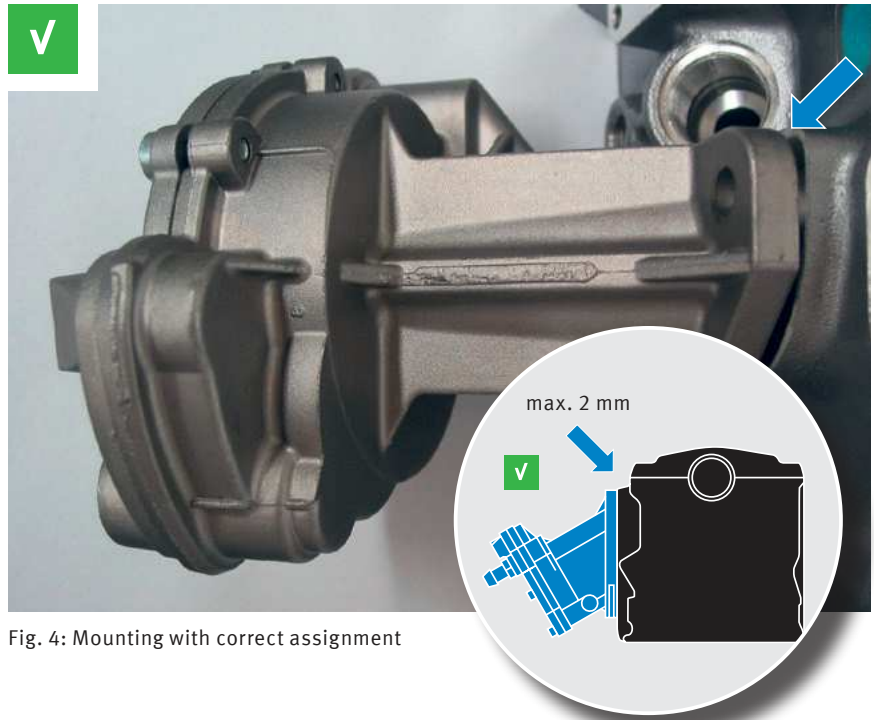
Fig. 4: Mounting with correct assignment

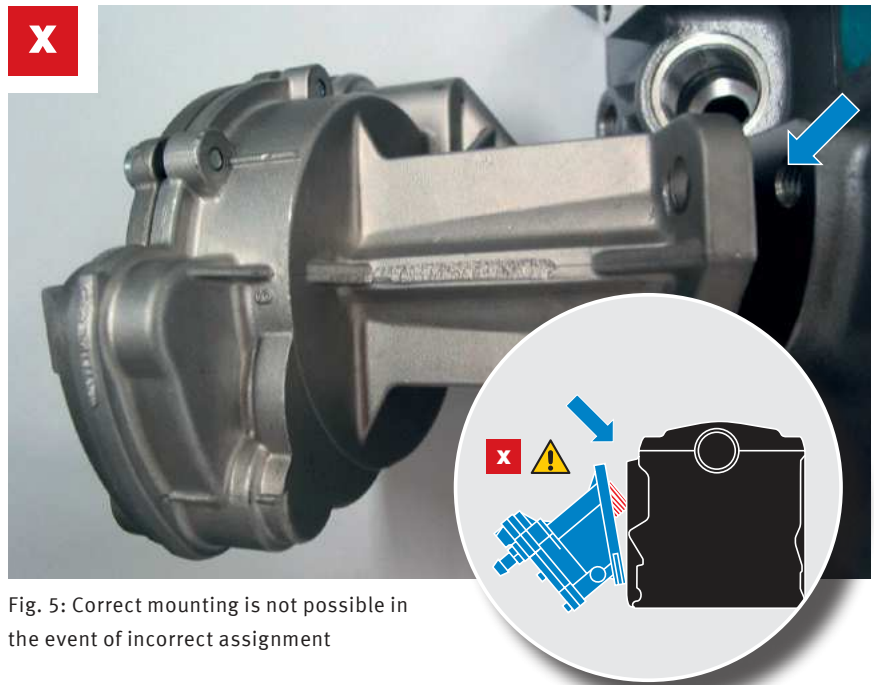
If it is not possible to press the vacuum pump to the flange (approx. 5 mm gap) without great effort, even with the cam on the opposite side of the connecting tappet, an incorrect assignment has very likely taken place.

Fig. 5: Correct mounting is not possible in the event of incorrect assignment

It is essential to check the chassis number, registration date and/or the part number of the old pump! Never attempt to solve this problem by modifying the connecting tappet (e.g. regrinding)!
