509194 Hyundai O-ring kit

Part Number: 509194

Vehicle: Hyundai models

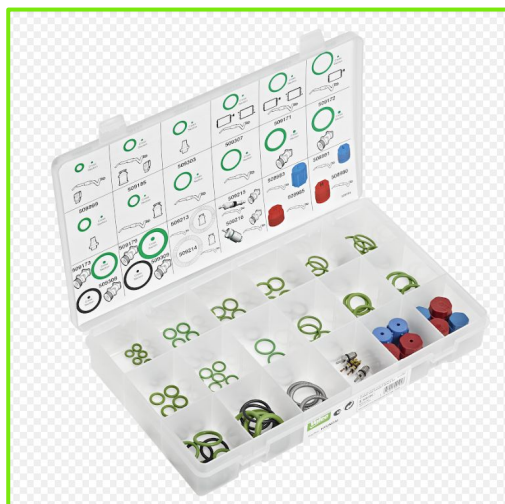
The Valeo technical hotline are receiving a number of calls where people are having issues with the air condition system on the vehicle and appear to be losing refrigerant through leakage. After a full investigation, the Valeo engineers have found the problem can normally be solved by simply changing the O'ring on the vehicle. As with most seal fittings in a vehicle, the AC O-ring can lose its sealing abilities due to loss of elasticity or cracks in the seal. A defective O-ring will let the refrigerant leak out, which can damage the neighboring components and compromise the vehicle AC efficiency.

If you find refrigerant pooling under the vehicle or if the air blowing through the AC vents is not cold, it's a possibility that the AC O-rings are damaged. Valeo recommends periodically checking AC O-rings and if they are found defective, replace them at the earliest convenience to avoid damaging the air-conditioning system. To help make this easier Valeo sells a Hyundai O-ring kit, part number 509194.

- To ensure a good sealing of the A/C loop, always replace an O'ring by another one that perfectly matches the original: same shape and diameter.
- Clean the O'ring and the spot where it will be located.
- The O'ring must be lubricated with the oil corresponding to the A/C loop application.
