Connecting Cable, camshaft adjuster actuating solenoid

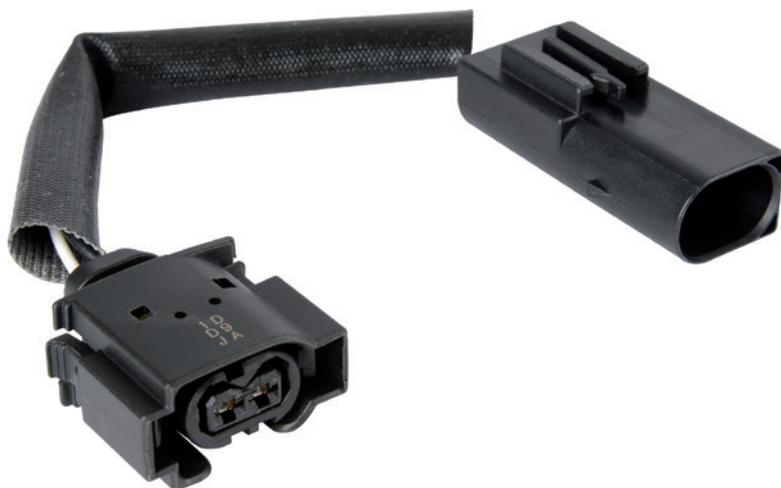
Oil leaking from the camshaft sensor plug is a familiar problem on Mercedes-Benz petrol engines. The fault is design-related and cannot be rectified in the long term by replacing the sensor. Due to the capillary effect, the oil can infiltrate the harness to reach the control unit and eventually cause electronic failure and damage to individual parts. Such damage can be prevented with the Herth+Buss oil-stop cable. Fine copper sleeves have been incorporated into both lines of the oil-stop cable in order to prevent the oil from spreading. These

have subsequently also been wrapped in heat-shrink tubing. We recommend installing one oil-stop cable on every M111 (engine code), two on every M271 and as many as four on every M272 (V6).

How long does it take to fit the oil-stop cable? Fitting it will take a maximum of five minutes. Detach the harness from the sensor before inserting the oil-stop cable from Herth+Buss between the connection on the sensor and the old harness.
