LuK Service Info

LuK RepSet 623 3787 09

Disconnect clutch for hybrid vehicles

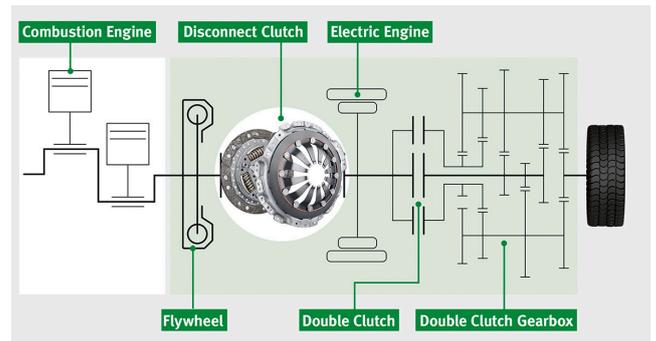
Image 1: System design of the plug-in hybrid drive

The vehicle models listed above feature a plug-in hybrid system. The drive can be powered by the internal combustion engine and/or by the electric motor. In order to use the drive systems as effectively as possible, they must be able to be disconnected or decoupled from each other in certain driving conditions. This task is performed by the disconnect clutch. On these vehicles, the disconnect clutch is located between the internal combustion engine and the electric motor along with the downstream dual-clutch gearbox.

When the vehicle is being powered solely by the internal combustion engine, the disconnect clutch is engaged. When the vehicle is being powered solely by the electric motor, the internal combustion engine is disconnected from the drive. In this driving condition, the disconnect clutch is disengaged. In “boost” mode, the electric motor supports the internal combustion engine during acceleration. In this case, both systems are used to power the drive with the disconnect clutch engaged.
